NASA Technical Memorandum TM 107554

Debris/Ice/TPS Assessment And Integrated Photographic Analysis For Shuttle Mission STS-52

December 1992

Gregory N. Katnik
NASA/Kennedy Space Center

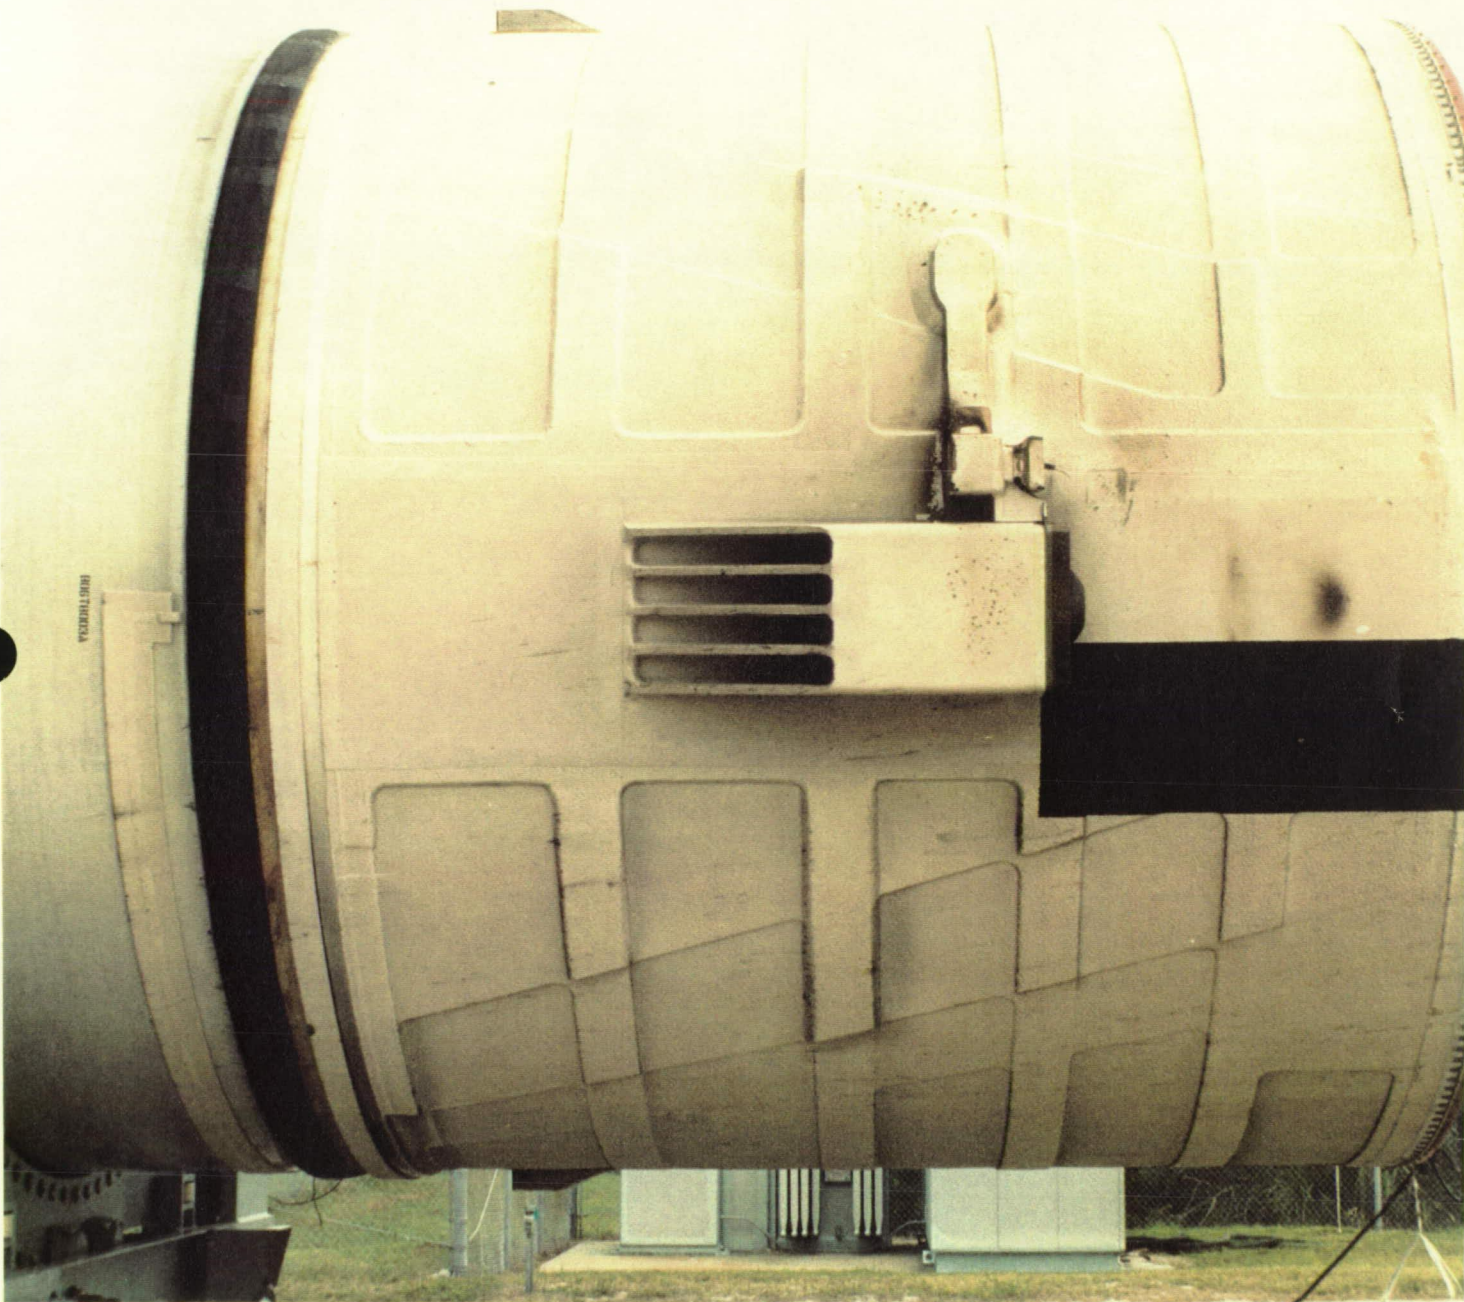
The RH forward skirt was missing no TPS, but did have two MSA-2 debonds. Minor blistering of the Hypalon paint occurred on the forward ET/SRB attach point. Both RSS antenna covers/TPS were intact and undamaged.

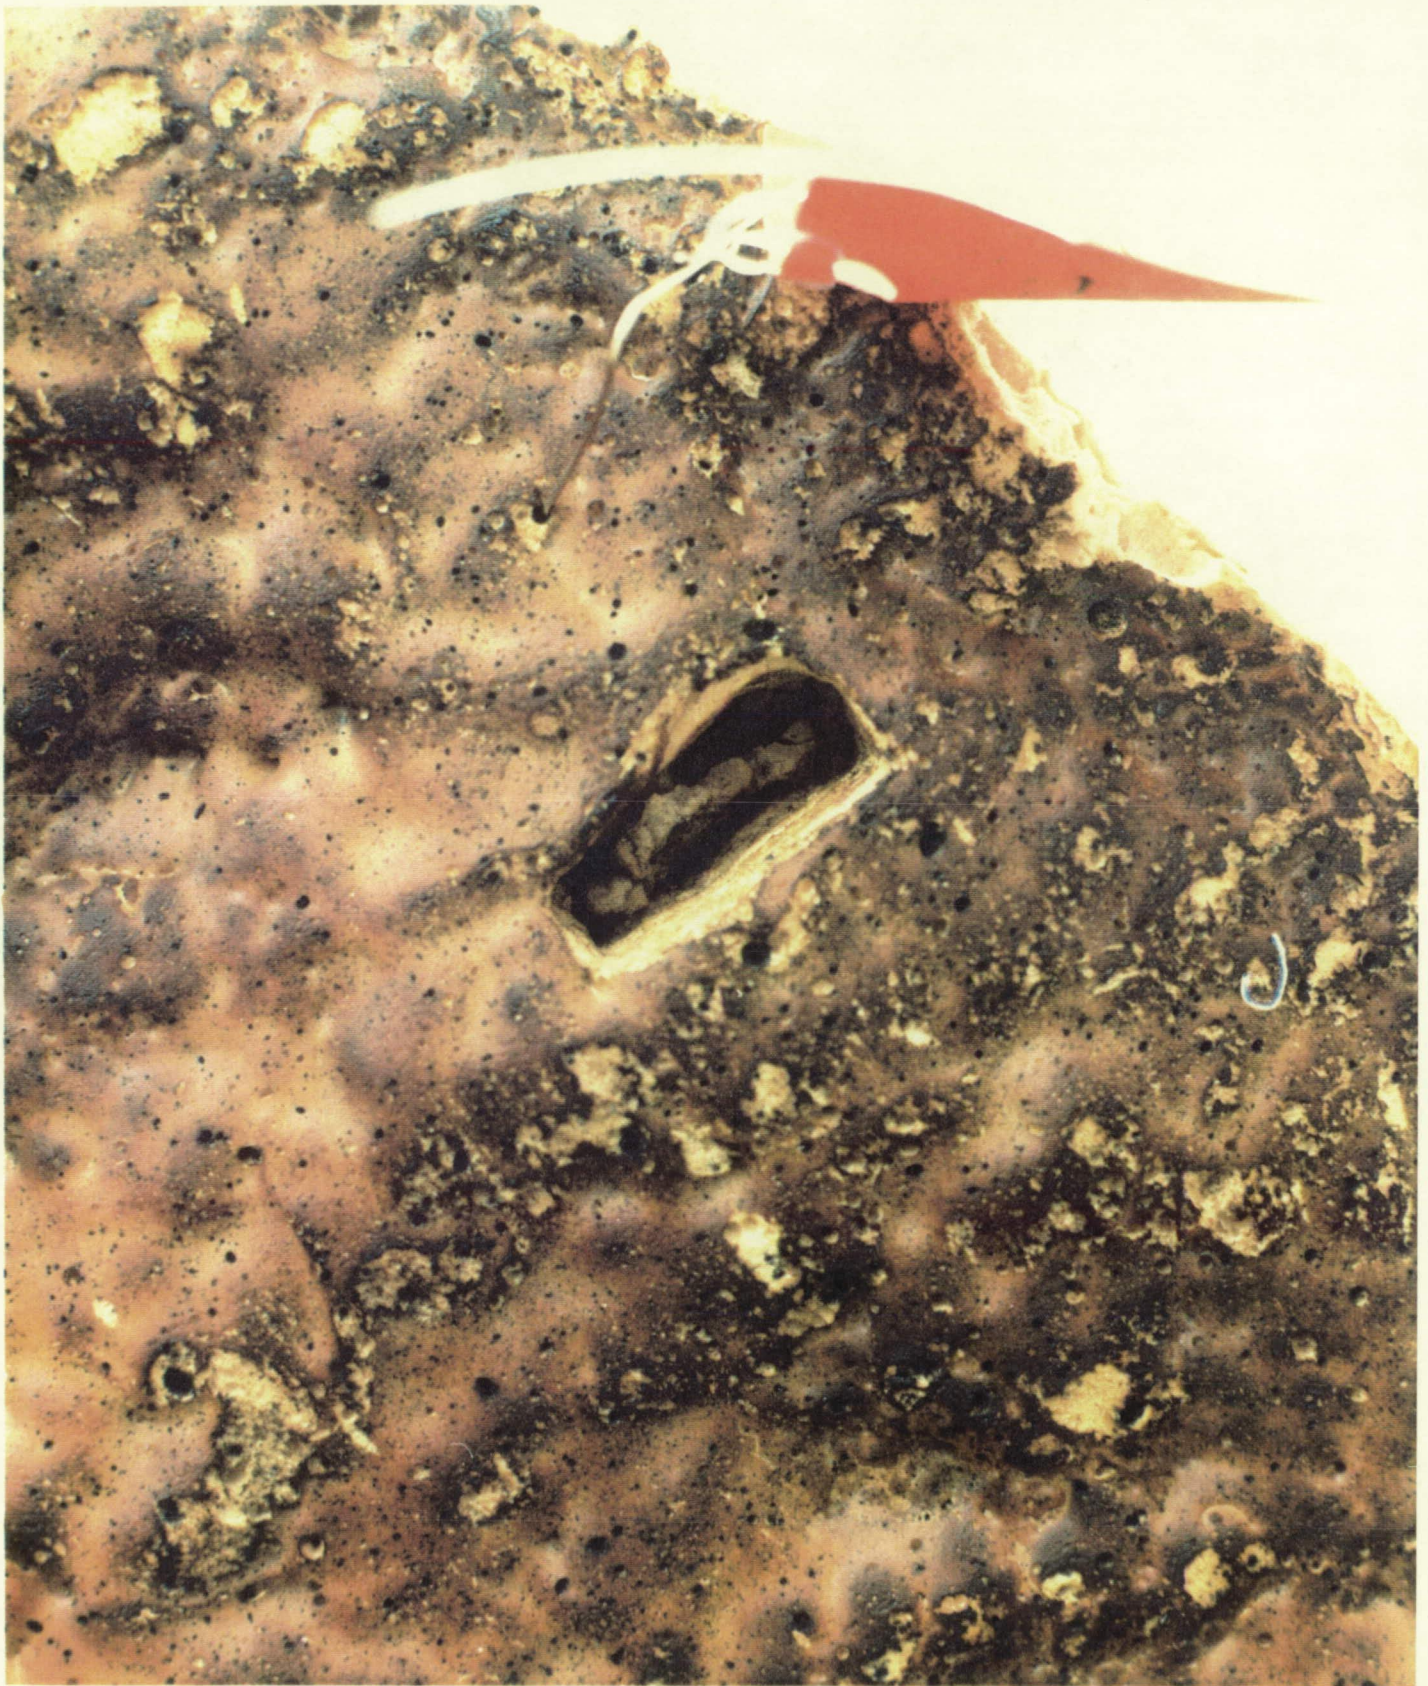
Two cavities were present in the forward-facing ETA ring TPS. Post flight analysis revealed no evidence of embedded debris or foreign material. The cavities had experienced a full ascent heat load and were most likely present prior to launch rather than an in-flight occurrence.

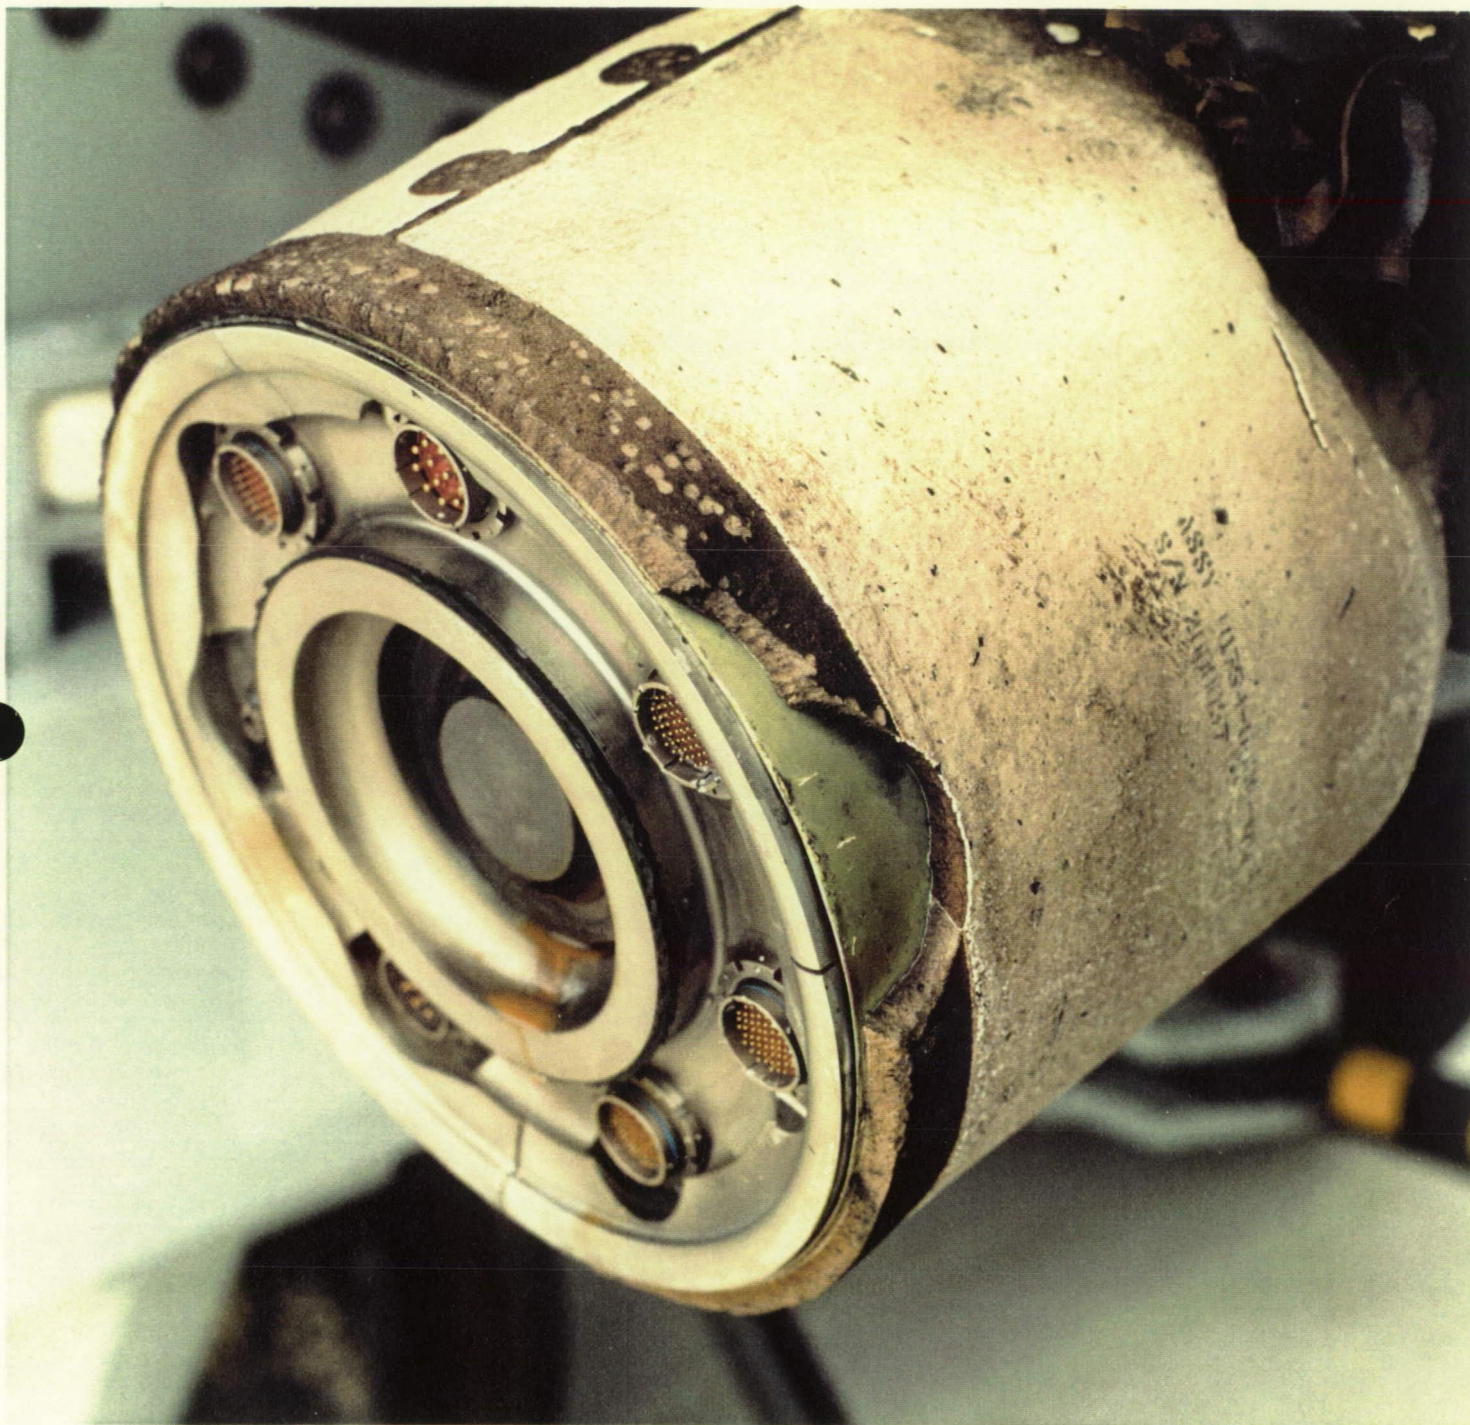
The upper strut fairing (milk can) was missing a 7" x 3" piece of K5NA. The substrate was charred.

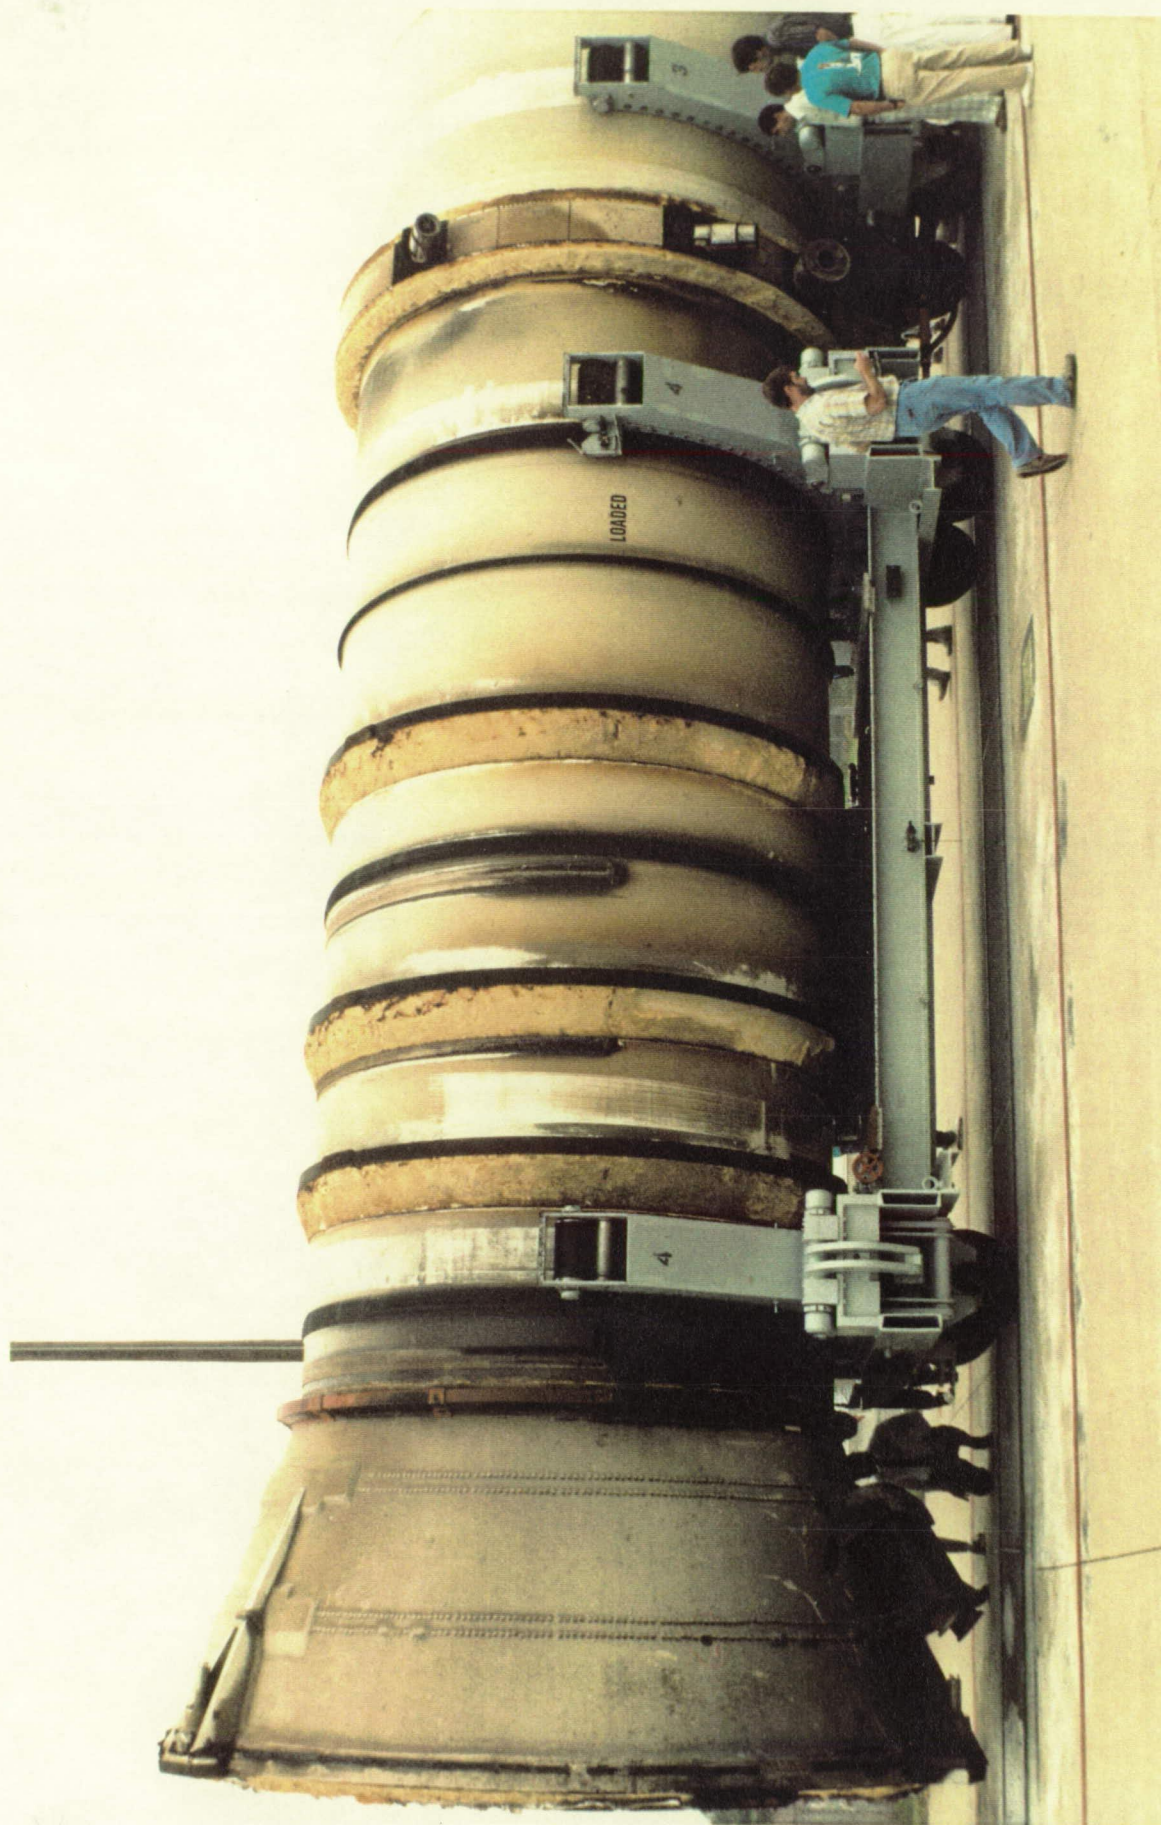
Post flight condition of the RH aft booster. Separation of the aft ET/SRB struts appeared normal. All three aft booster stiffener rings sustained water impact damage.

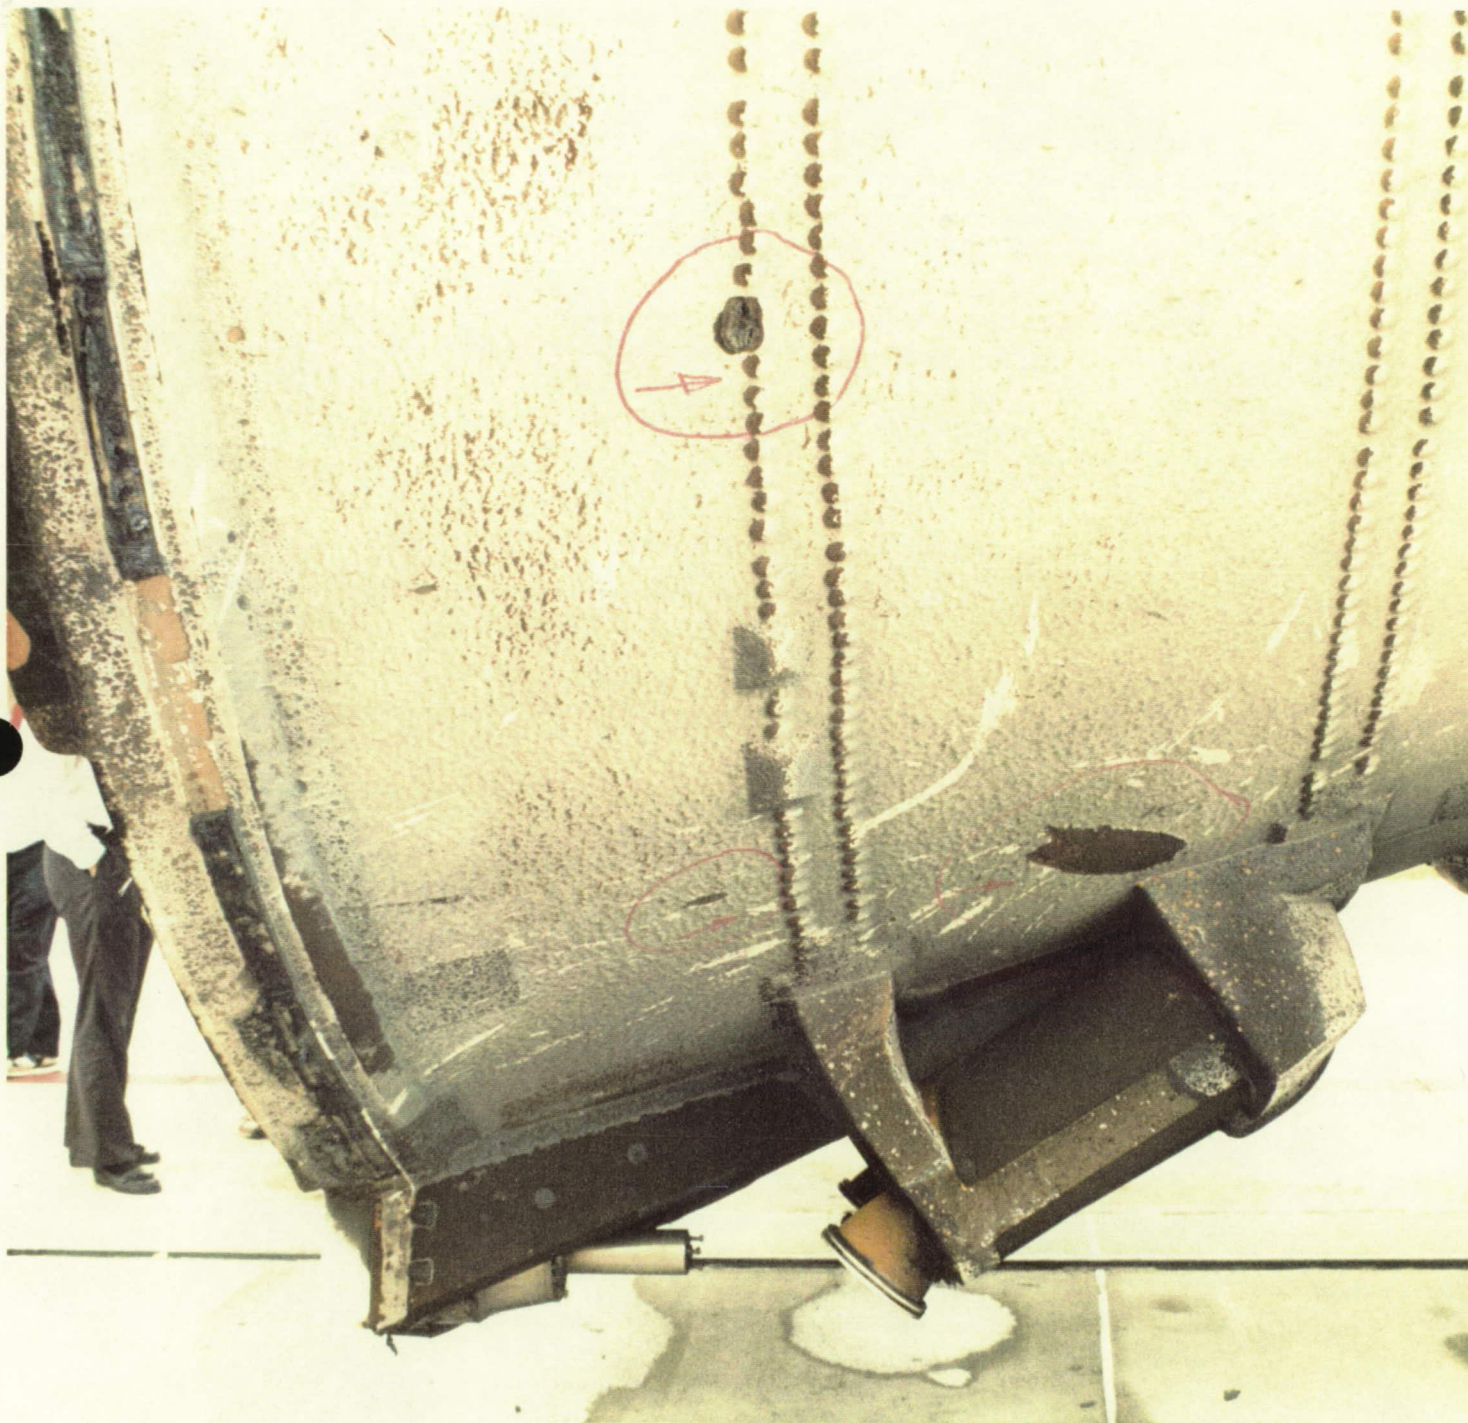
Three divots, one of which exposed two fastener head covers, occurred on the aft skirt acreage TPS near the location of the booster separation motors (BSM's).

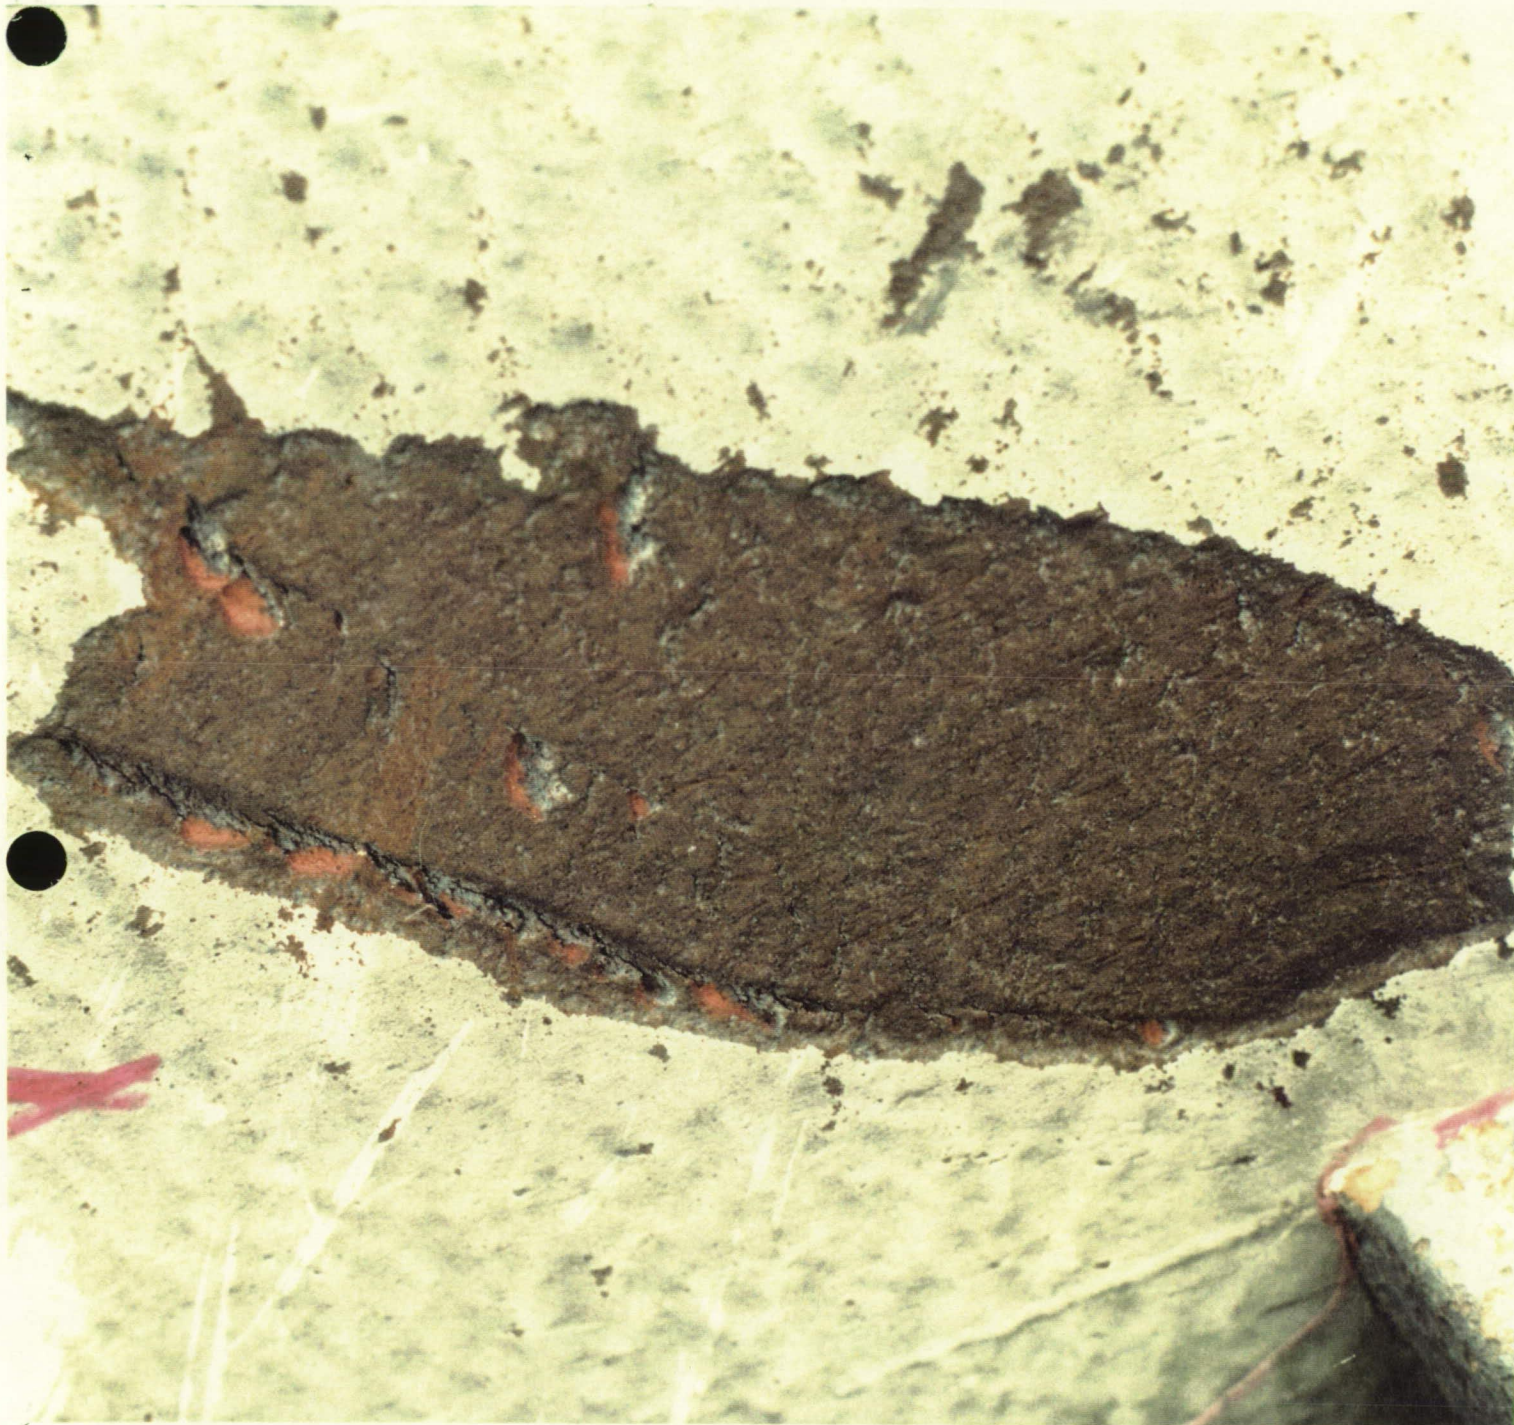
Close-up view of the 13" x 5" MSA-2 divot. Post flight analysis revealed a lack of high heat exposure, but did show signs of debris impacts followed by in-flight erosion. However, no foreign debris particles were detected in the remaining material. The divot most likely occurred during descent since areas of MSA-2 within the divot were peeled upward toward the nosecone and exhibited forward fracture sooting.

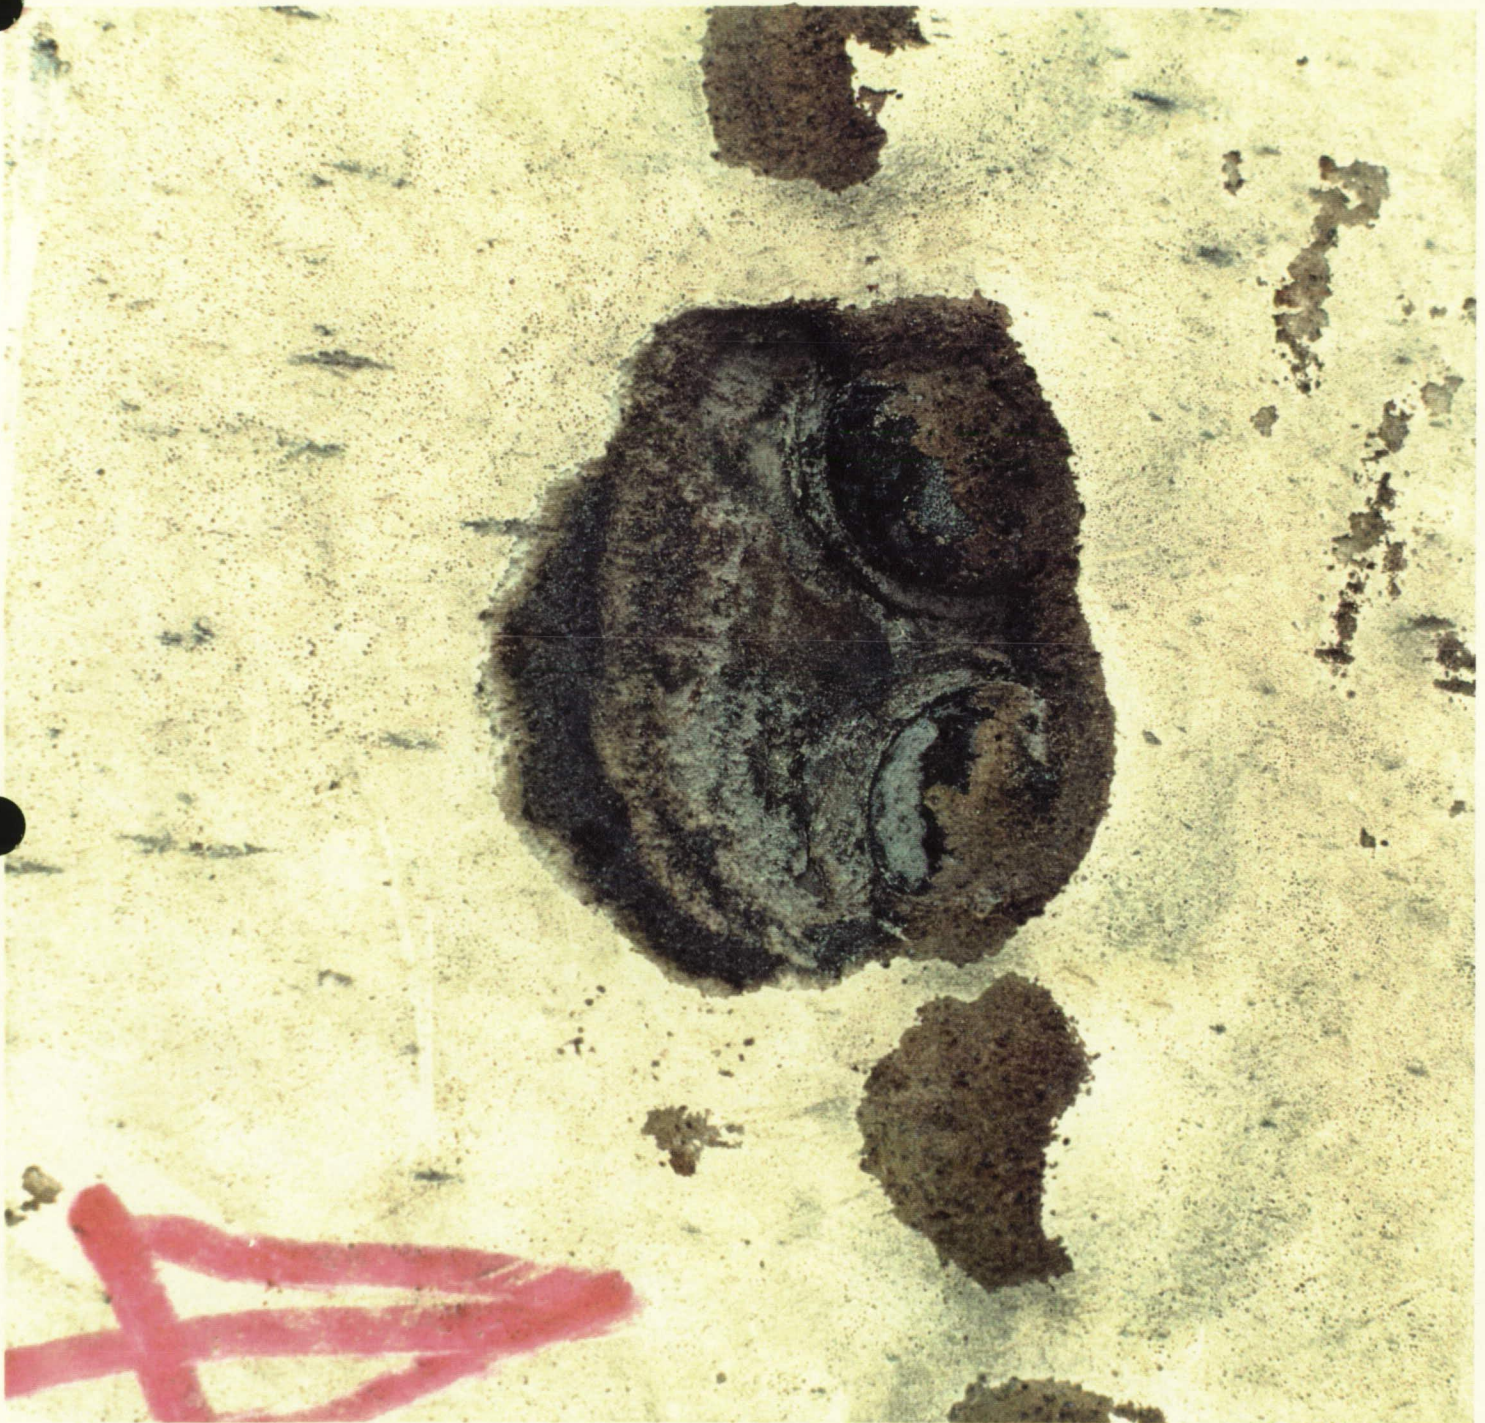
This divot exposed two fastener head covers and a small area of substrate. Post flight analysis revealed no foreign debris or high ascent heating effects. The divot was caused by a "smiley" starting aft of the fasteners during descent, which sooted the aft fracture surface before the MSA-2 broke loose.

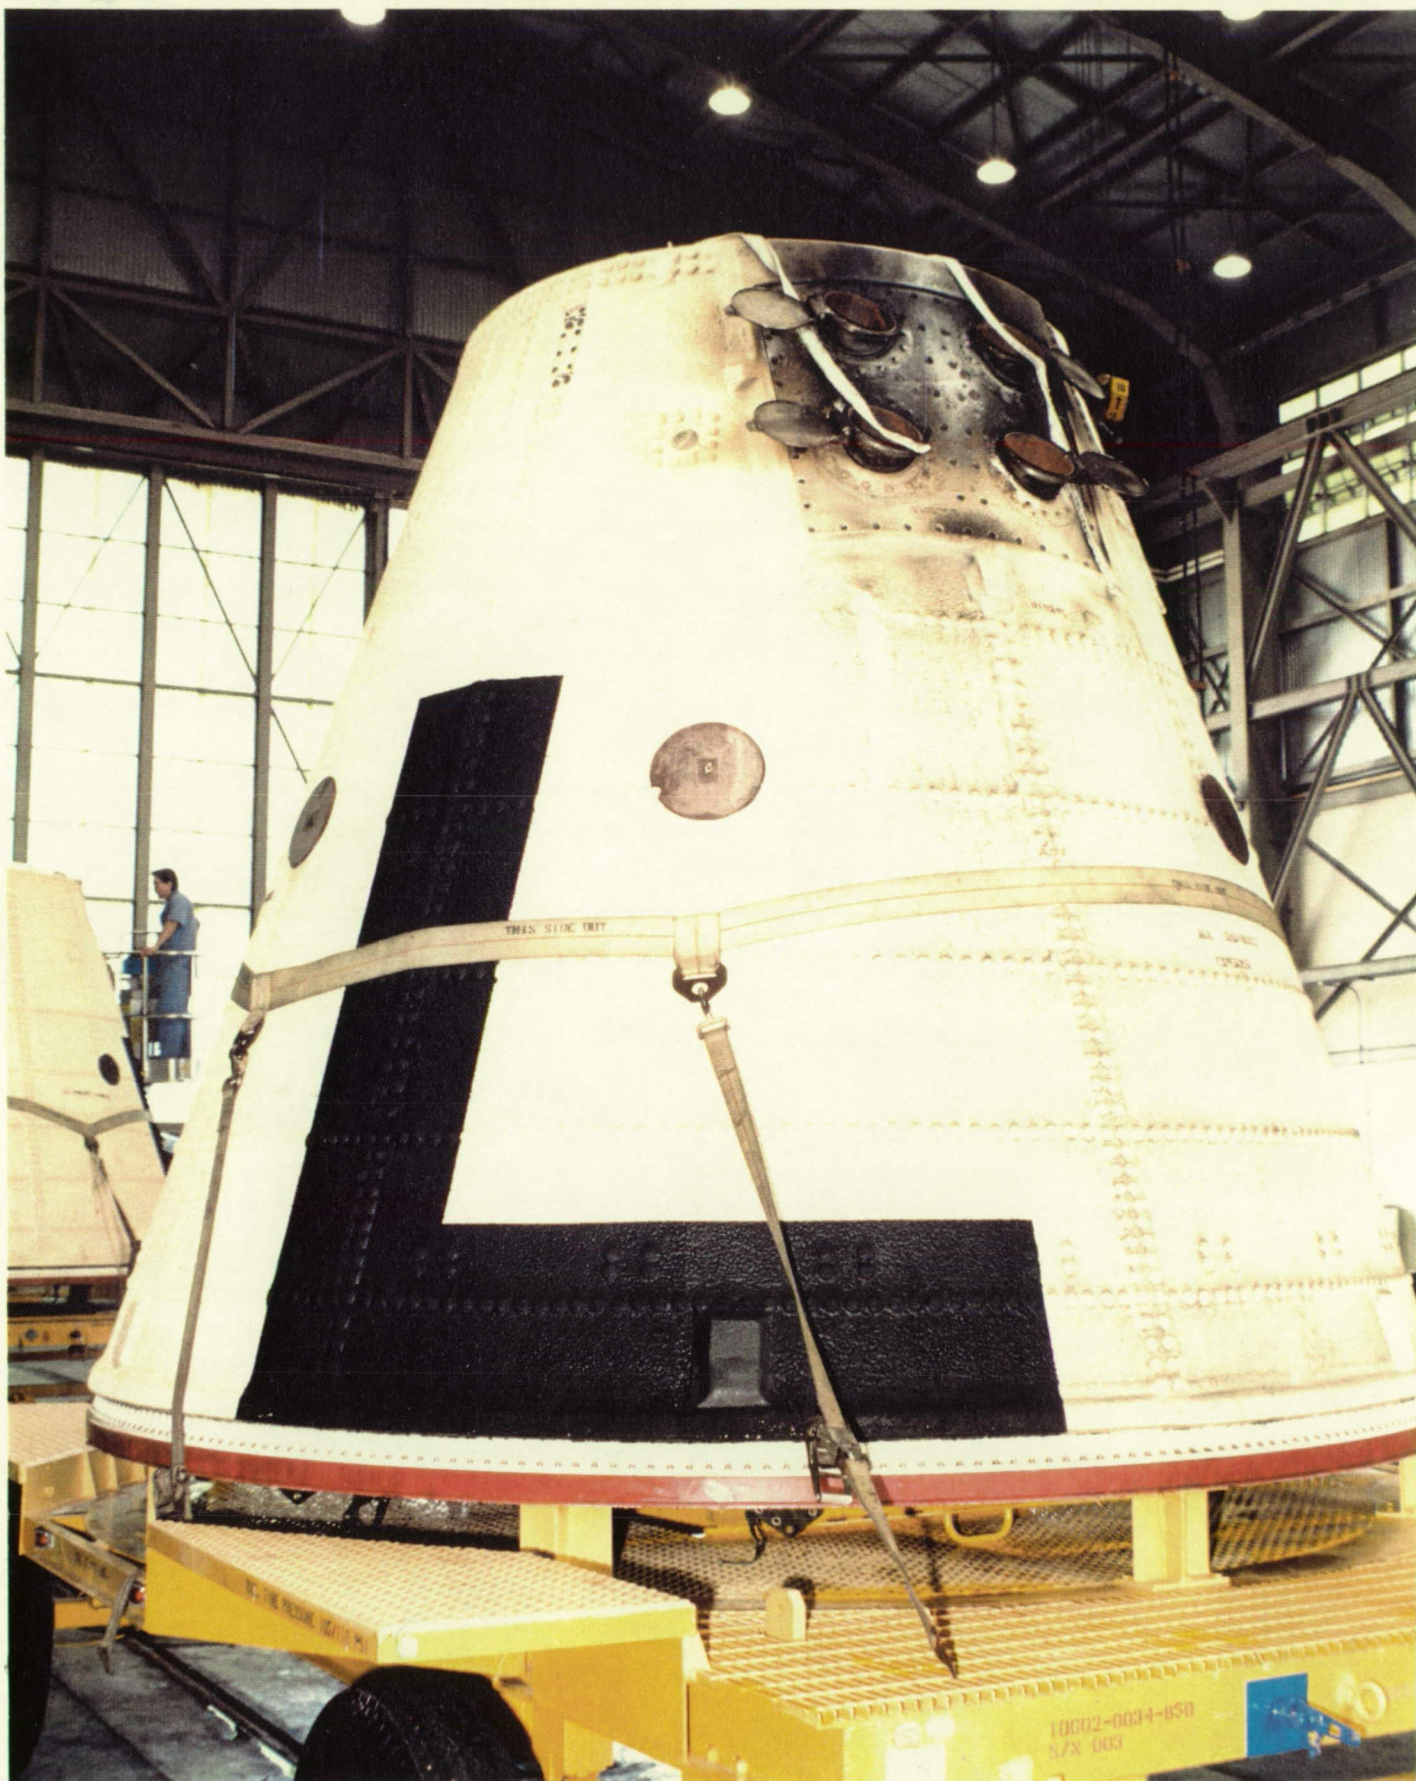
The LH frustum was missing no TPS, but had 27 MSA-2 debonds over fasteners. The BSM aero heat shield covers were locked in the fully opened position.

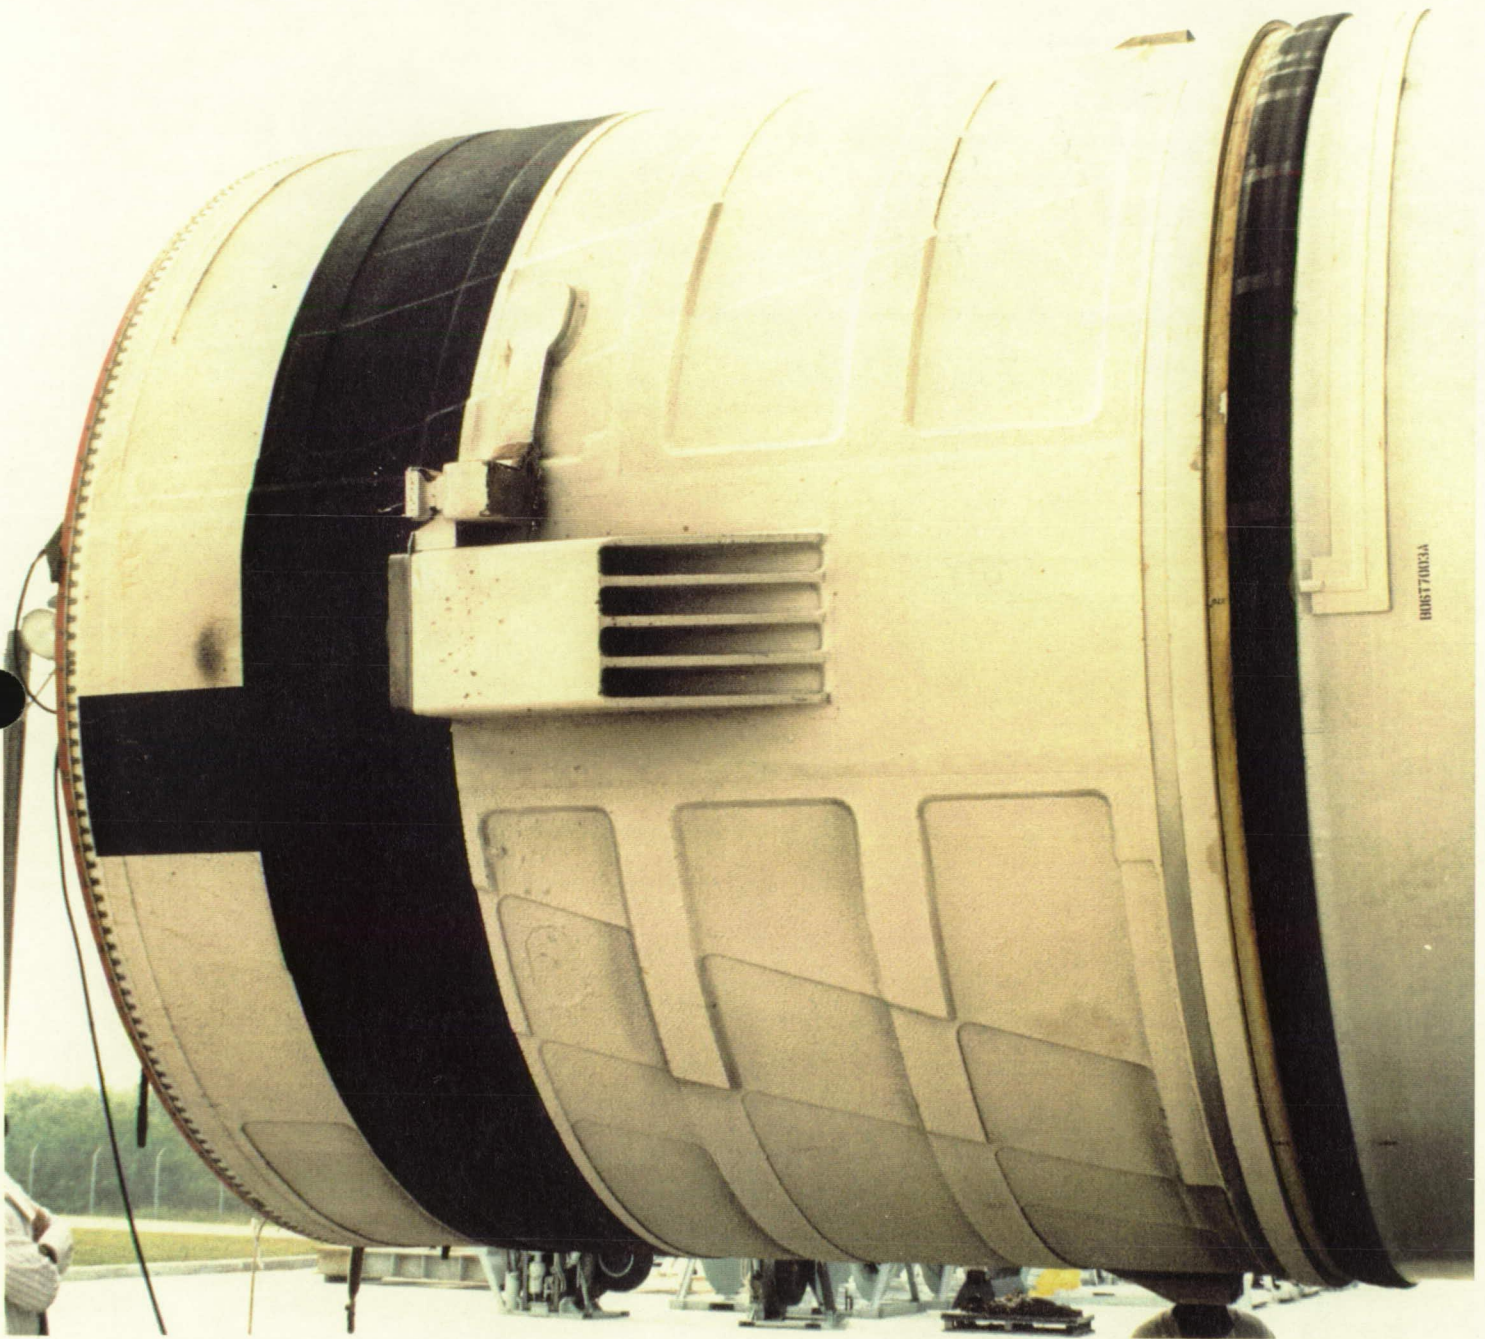
The LH forward skirt exhibited no debonds or missing TPS. Minor blistering of the Hypalon paint occurred in localized areas. Both RSS antenna covers/TPS were intact and undamaged.

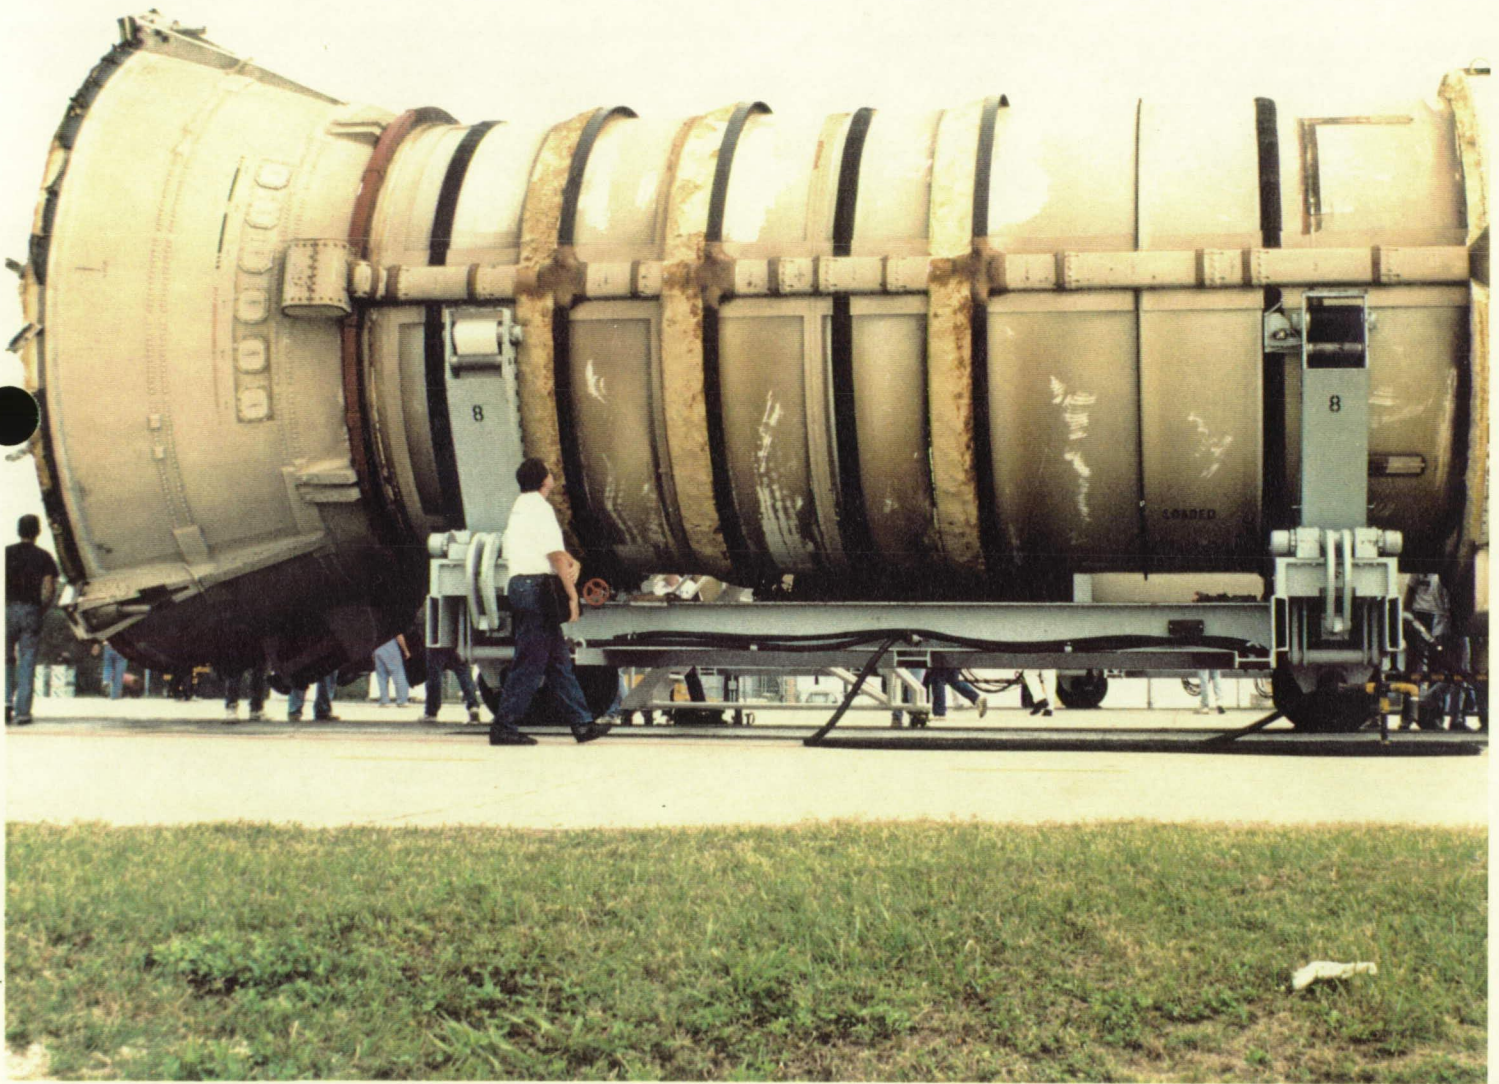
Post flight condition of the LH aft booster. The ET/SRB aft struts, ETA ring, IEA, and IEA covers appeared undamaged. All three aft booster stiffener rings sustained water impact damage
